UNDERSTANDING

NON-RECTIFIED PORCELAIN & CERAMIC TILES

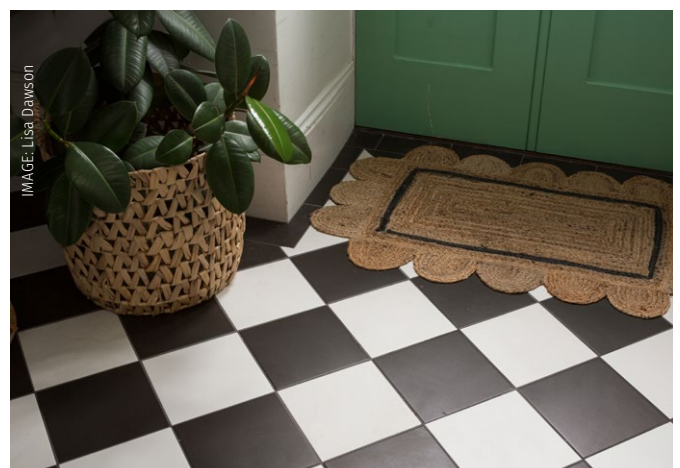
These differences can be overcome with the use of wider and varied grout joint widths. The image below shows Brompton Field Liquorice and Field Milk combined as a chequerboard, using varied width grout joints. This shows how the effect is largely lost when seen from above.

However, problems can arise when two products are combined (for example as a chequerboard layout, with

two colours) as the tolerances are likely to vary between each product- this is due to natural variation in the base material used for each production run, which will expand and/or contract in different ways, as well as size variation that will occur if the two products are produced on different production lines.
