## UNDERSTANDING

# NON-RECTIFIED PORCELAIN & CERAMIC TILES

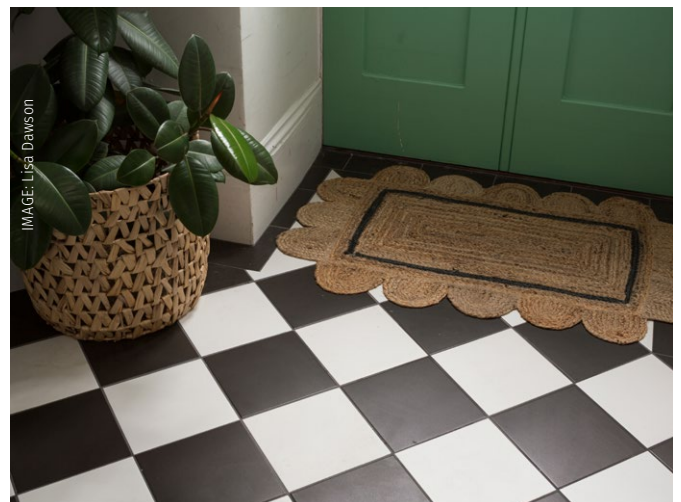
These differences can be overcome with the use of wider and varied grout joint widths. The image below shows Brompton Field Liquorice and Field Milk combined as a chequerboard, using varied width grouter joints. This shows how the effect is largely lost when seen from above.

However, problems can arise when two products are combined (for example as a chequerboard layout, with two colours) as the tolerances are likely to vary between

each product- this is due to natural variation in the base material used for each production run, which will expand and/or contract in different ways, as well as size variation that will occur if the two products are produced on different production lines.
